Stantec Consulting Services Inc.
2335 Highway 36 West
St. Paul MN 55113
Tel: (651) 636-4600
Fax: (651) 636-1311

October 15, 2013
File: 193802472

Reference: Eveleth City Auditorium Renovation – Phase II – Facility Plan

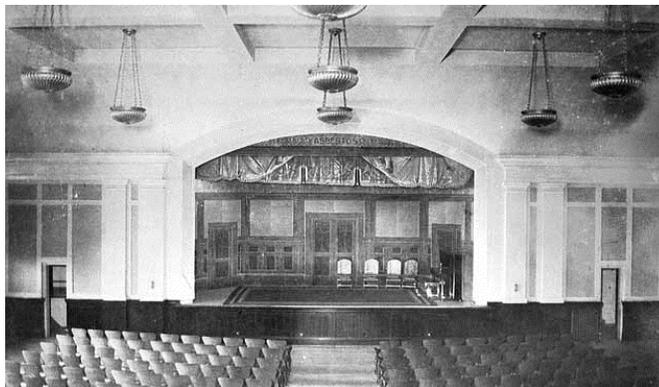
Large pendant lights could be used in lieu of the recessed can lights. The ceiling has a pattern of 12 squares in it. The center of these squares is where the original lights were installed (see photo below). The lights were large (i.e. 4 to 5 foot diameter) chain hung bowl lights. The cost to reproduce custom replicas of the lights could be as high as \$10,000 to \$15,000 per light. Similar looking commercially available lights of this size range from \$2,000 to \$8,000 per light. These lights are identified as type "A" on drawing E202 in **Appendix C**. There is a great range of quality and aesthetics of these commercially available lights. If it is desired to pursue this option we would recommend obtaining samples of the lights and have them temporarily installed to assist in the selection of the fixture.

Photo of Original Chain Hung lights in Auditorium

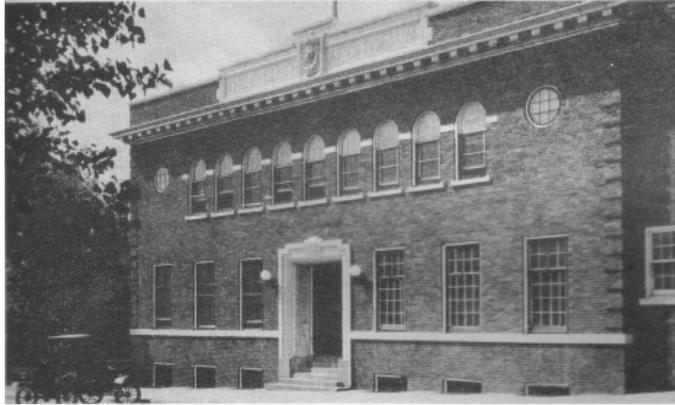
The existing exterior lights will remain as is, except for the lights at the main entrance (south side). The original lights in this location are surface mounted fixtures with a white globe (see photo below). The proposed new fixtures are identified as type "B" on drawing E202 in **Appendix C**. These lights were selected to match the existing fixtures.

Photo of Original Exterior lights at Main (south) Entrance
